Aquatic Plant Management - Bottom Screens

Description of Method

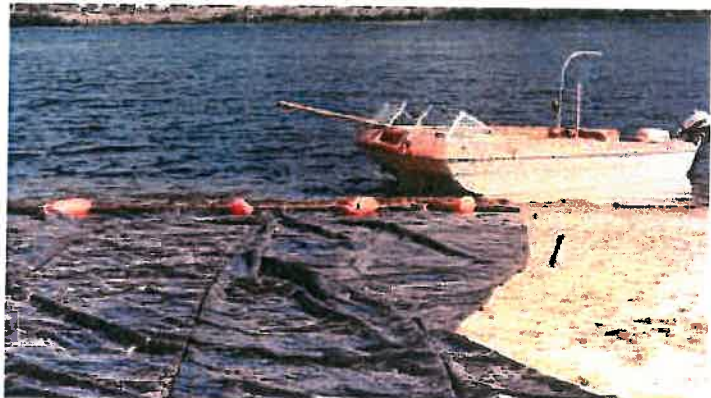
In this photo, bottom screening material is being prepared prior to installation around a boat dock.
